**REPORT  
TO  
GEORGE ROBB ARCHITECT**

**DESIGNATED SUBSTANCES SURVEY  
EGAN FUNERAL HOME  
203 QUEEN STREET SOUTH  
BOLTON, ONTARIO**

July 2008

70059

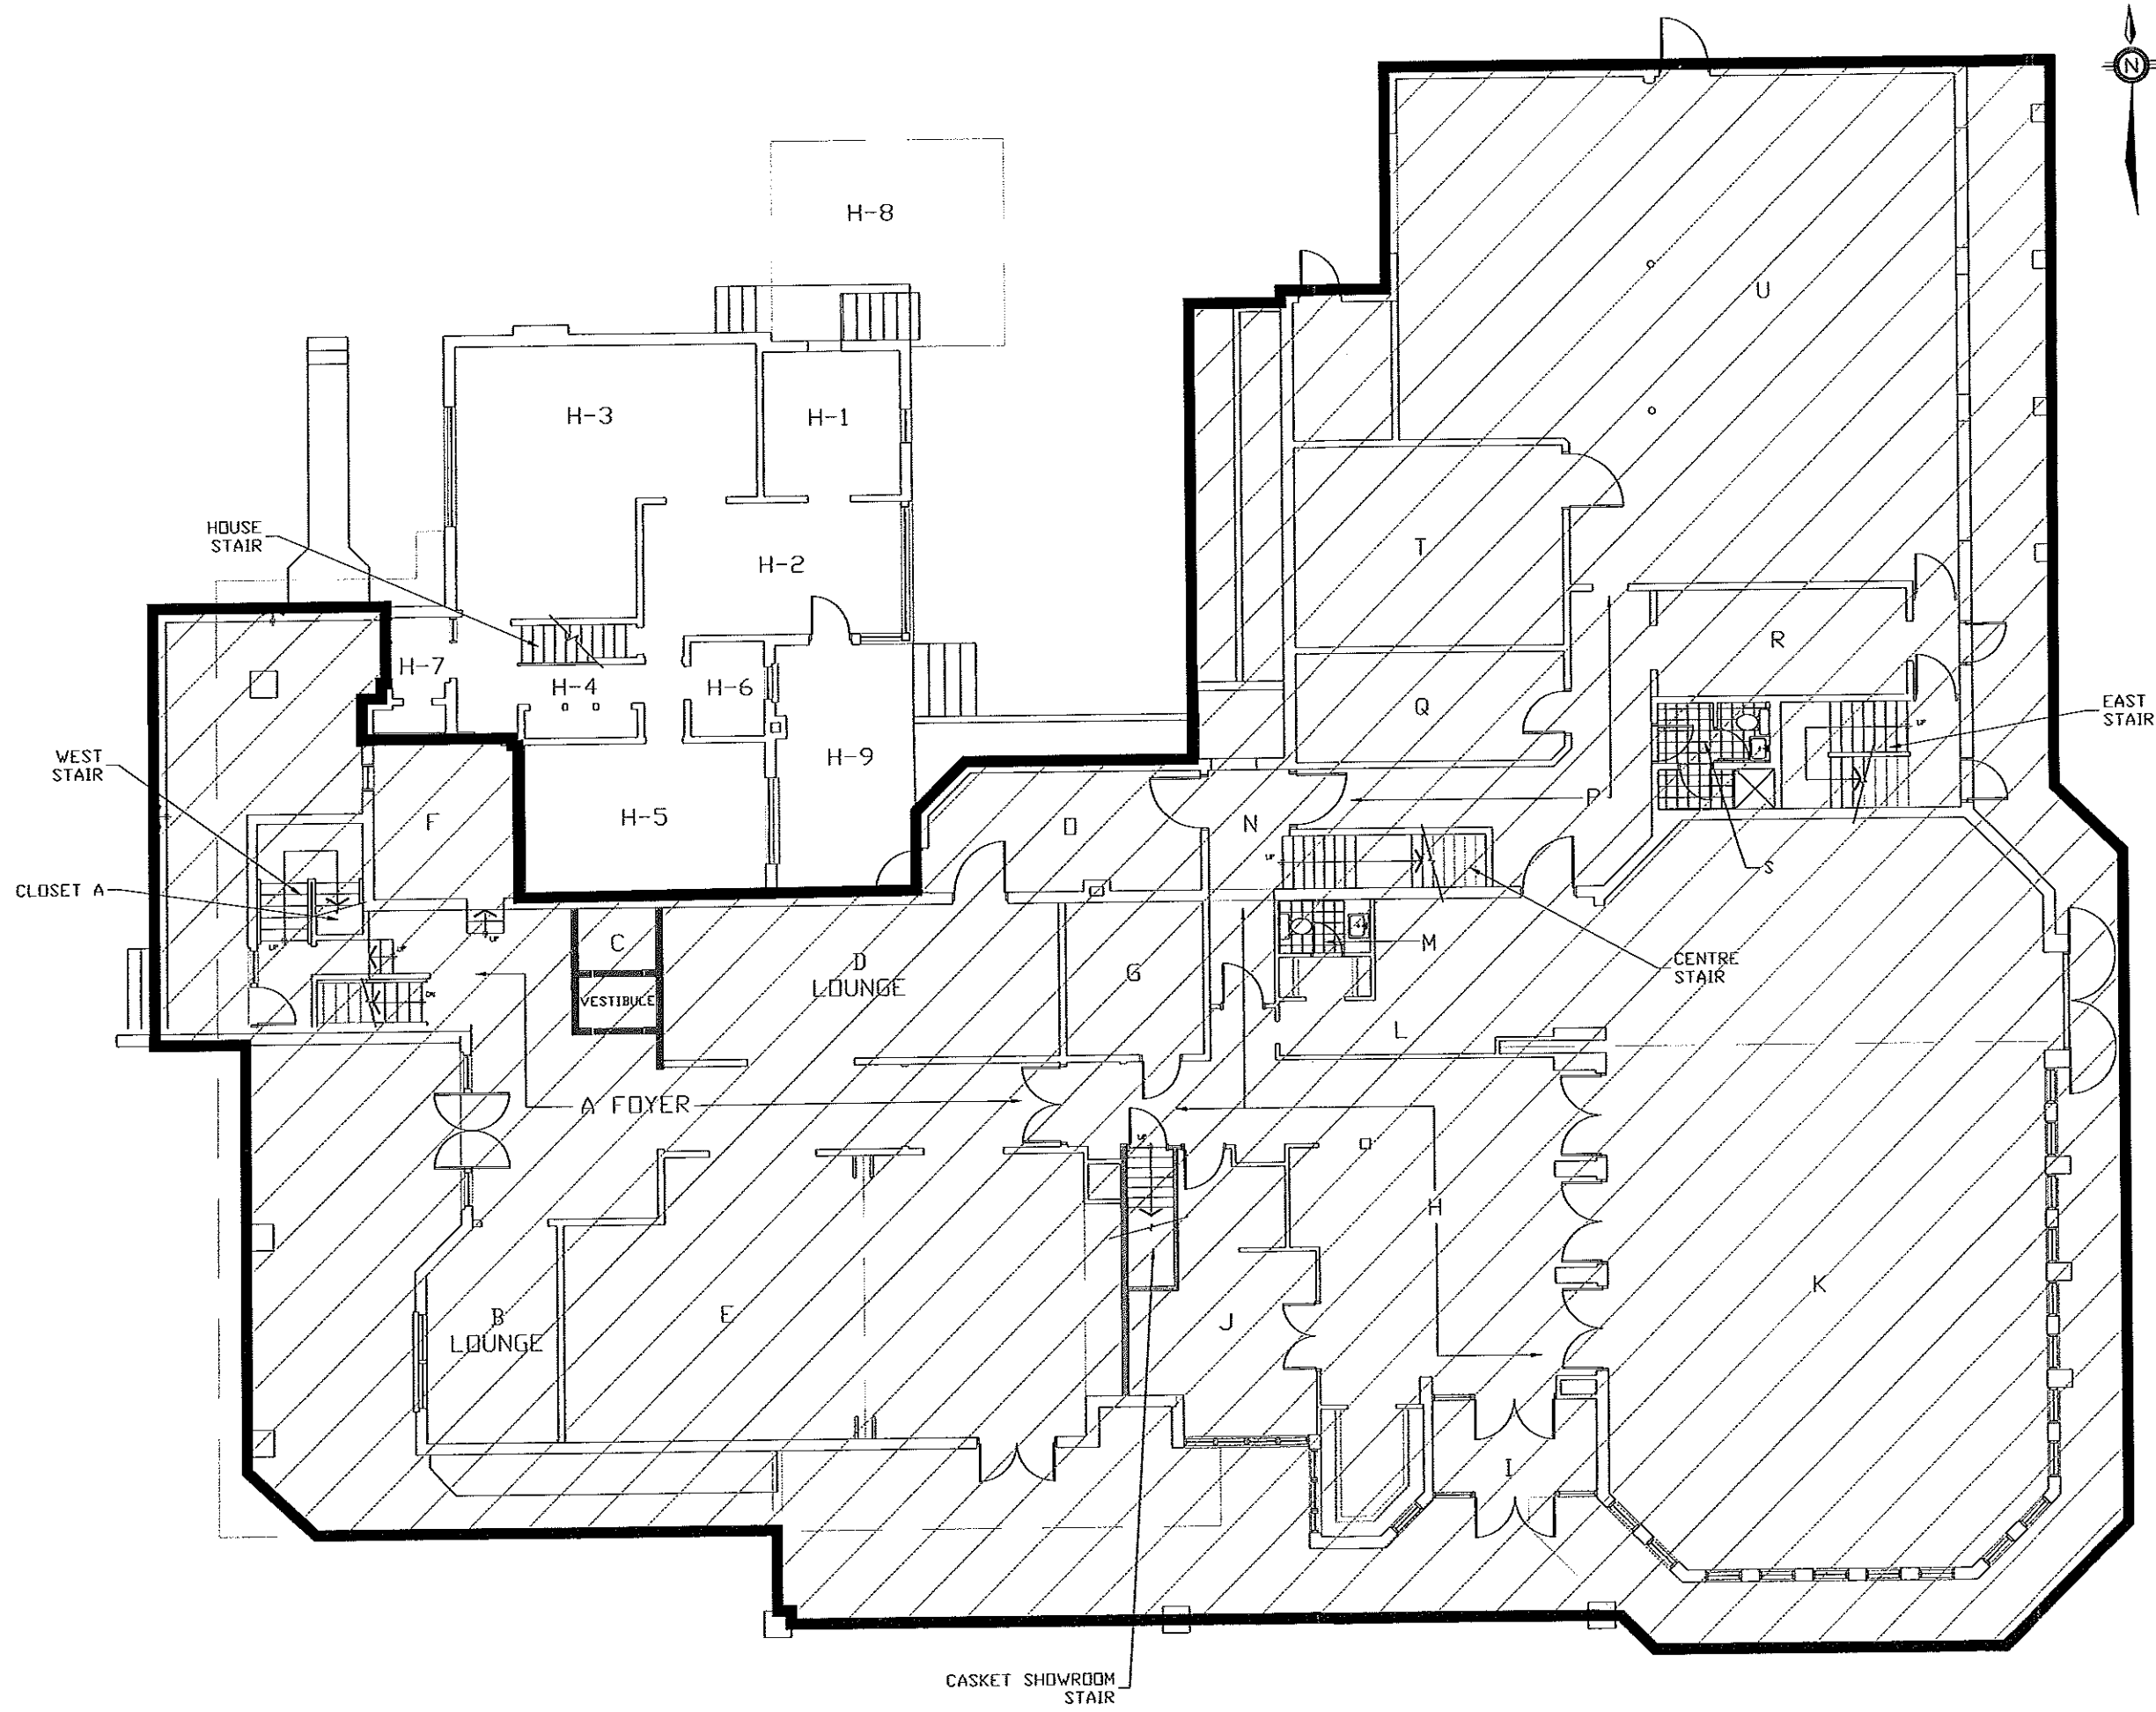
| Date: JULY 2008 | Scale: N.T.S. | Drawing No: 70059-1 |

- STUDY AREA
- ASBESTOS-CONTAINING DRYWALL JOINT COMPOUND ON WALLS
- SUSPECT ASBESTOS-CONTAINING VERMICULITE INSIDE WALL CAVITIES

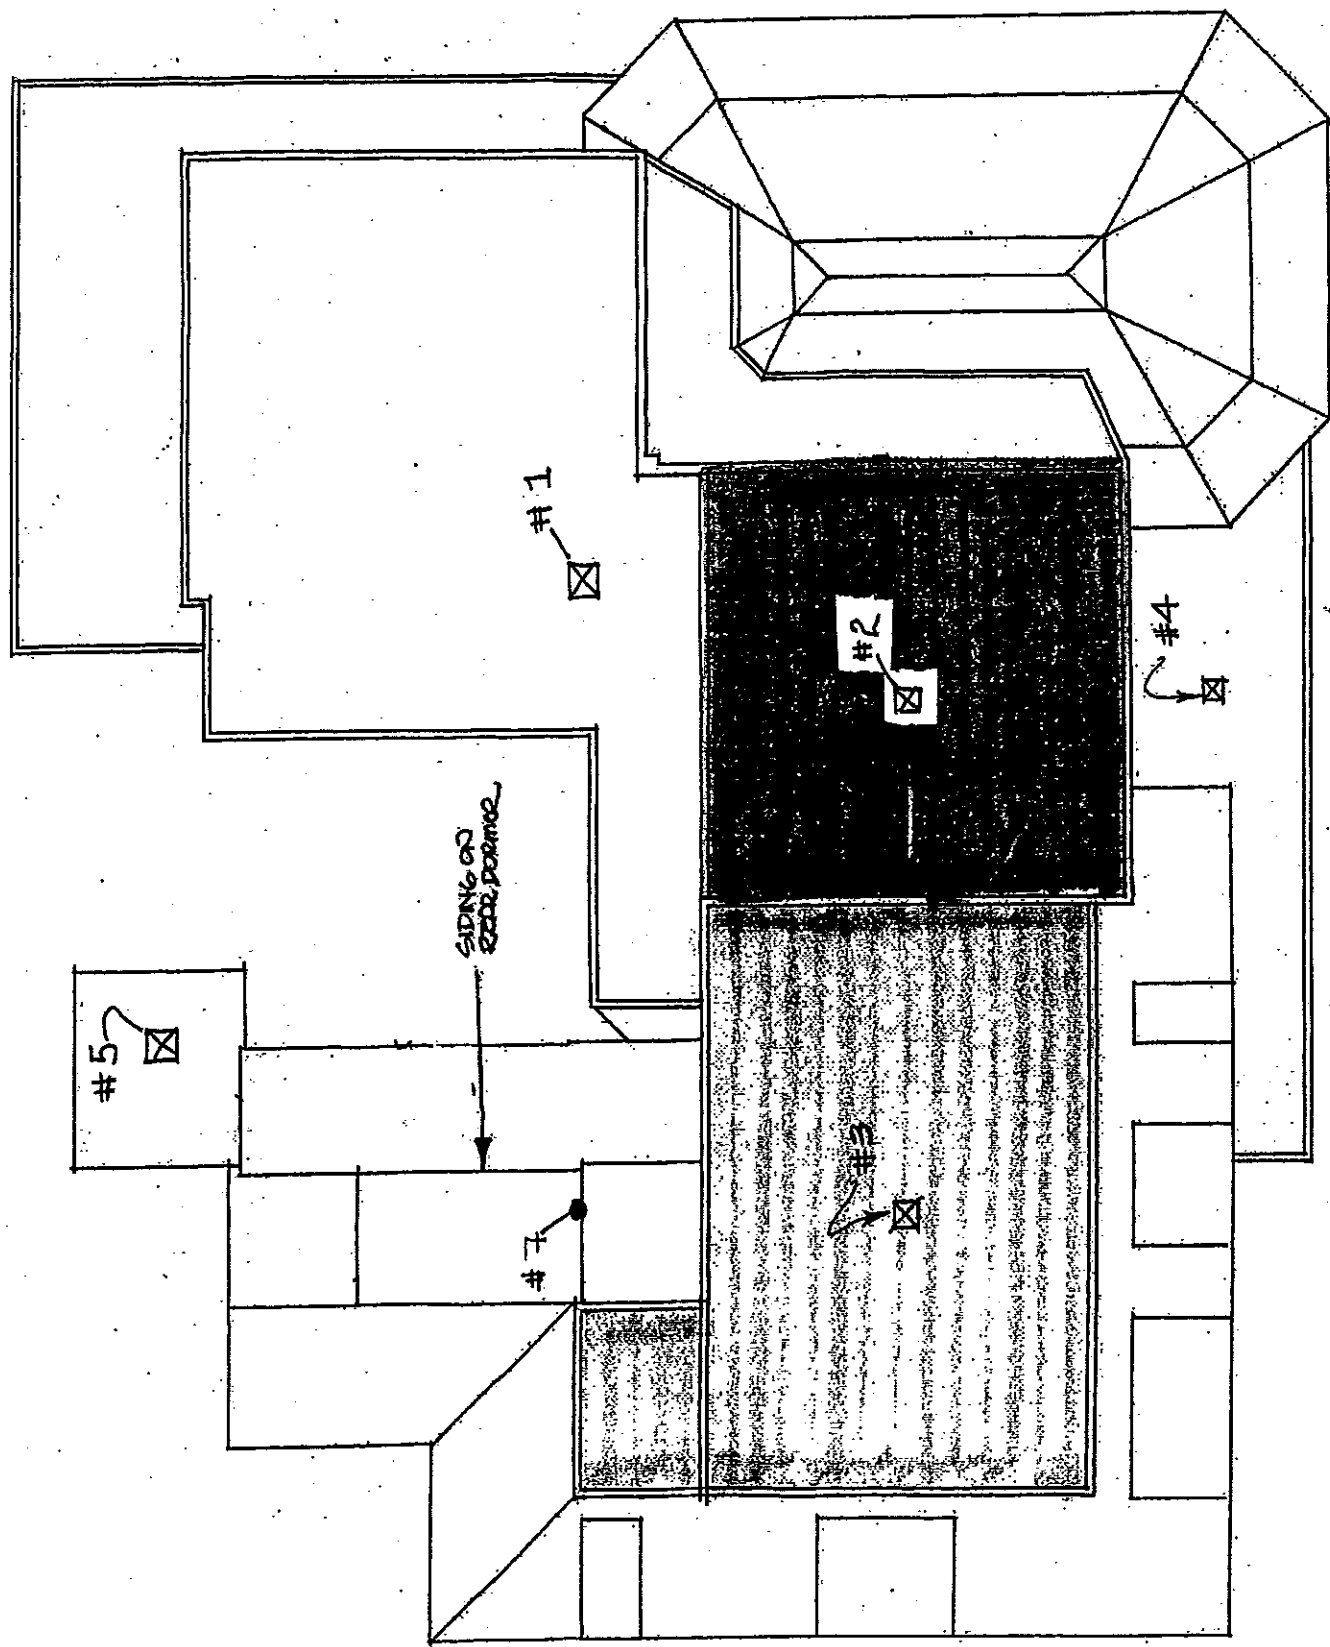
ROOF FLOOR PLAN (NTS)

| LOCATION | INVESTIGATION FINDINGS |
|---|---|
| 3 | Roofing over Apartment area. Roofing materials comprise pea stone gravel, multi-ply asphaltic felts, wood fibre insulation (Tentest), white expanded polystyrene foam on wood deck. Roofing materials tested by DCS not found to be "Asbestos-Containing Material" (<0.5% asbestos). |
